**Commercial Building Inspection Report**  
**& Property Condition Assessment Survey**  
**Report #: 6861-2025**

**Town of Qualicum Beach**

### **Eaglecrest Golf Course**

**444 Country Club Drive  
Qaulicum Beach, BC.**

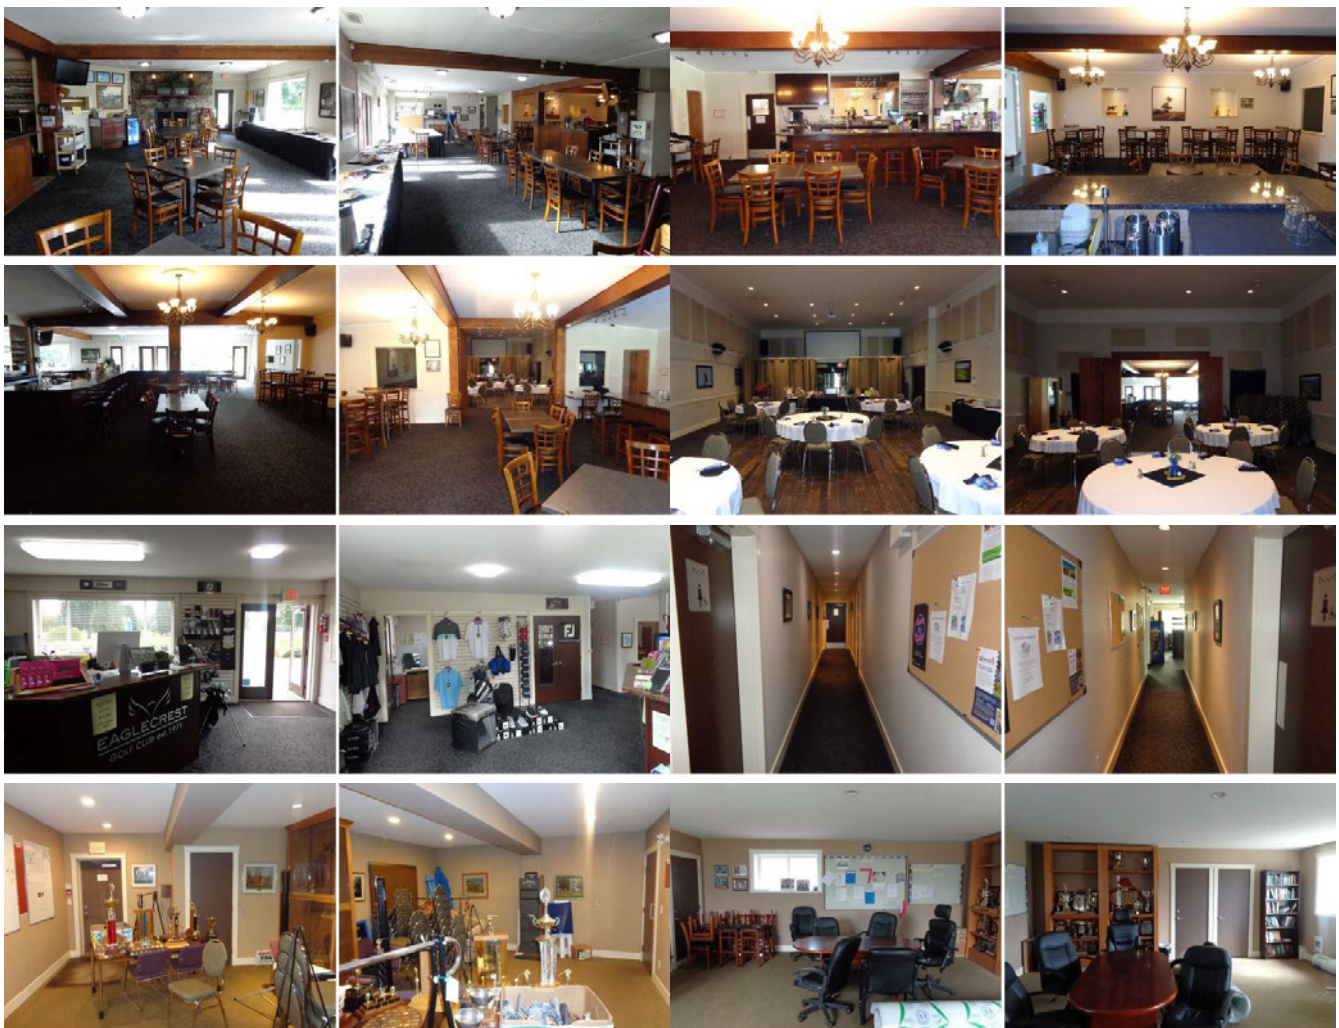
**12.4.1. Dining Room Conditions:** Black soot-like staining was observed on the upper portions of the dining room walls and ceiling. This discoloration is notably present around HVAC metal register covers, recessed lighting fixtures, the tops of windows, and in the corners where walls meet the ceiling.

The exact cause of this condition is currently unknown. However, such staining is not typical and may be indicative of issues such as incomplete combustion from heating equipment, air circulation imbalances, or particulate accumulation from candles, cooking, or other airborne contaminants.

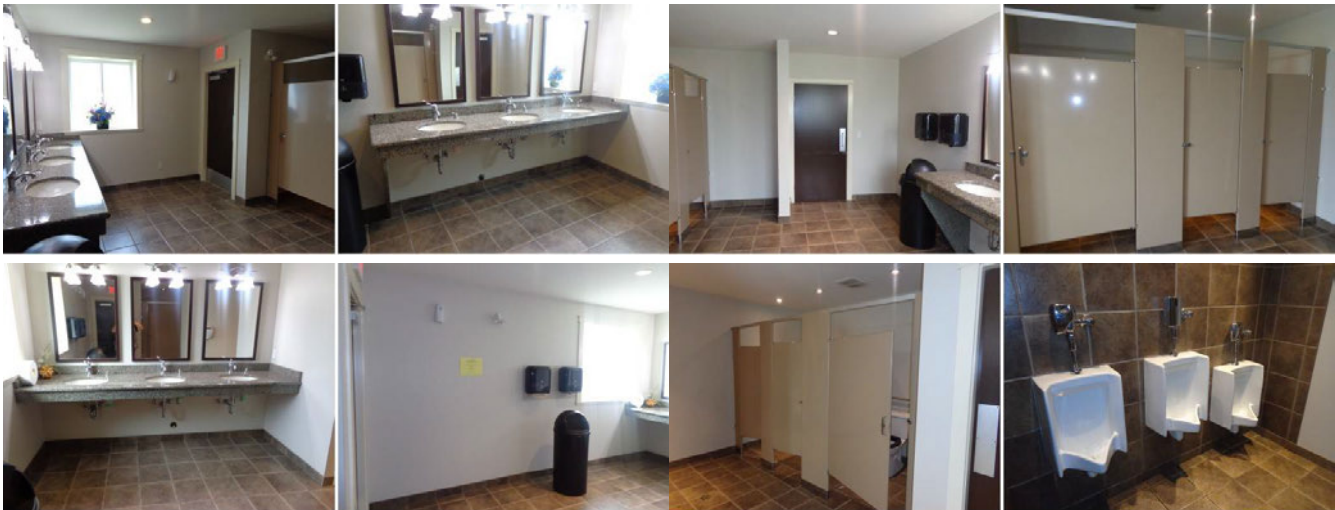
**12.6. Public Restrooms:** Public rest rooms are functional and in satisfactory condition.

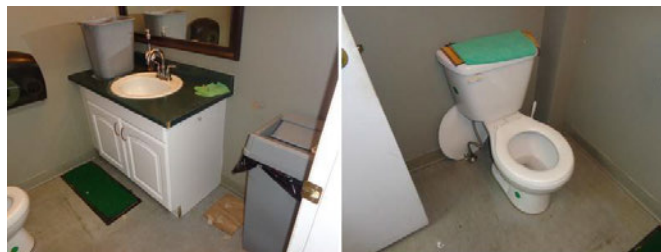
**12.7. Employee Restrooms:** Employee rest room is functional and in satisfactory condition.

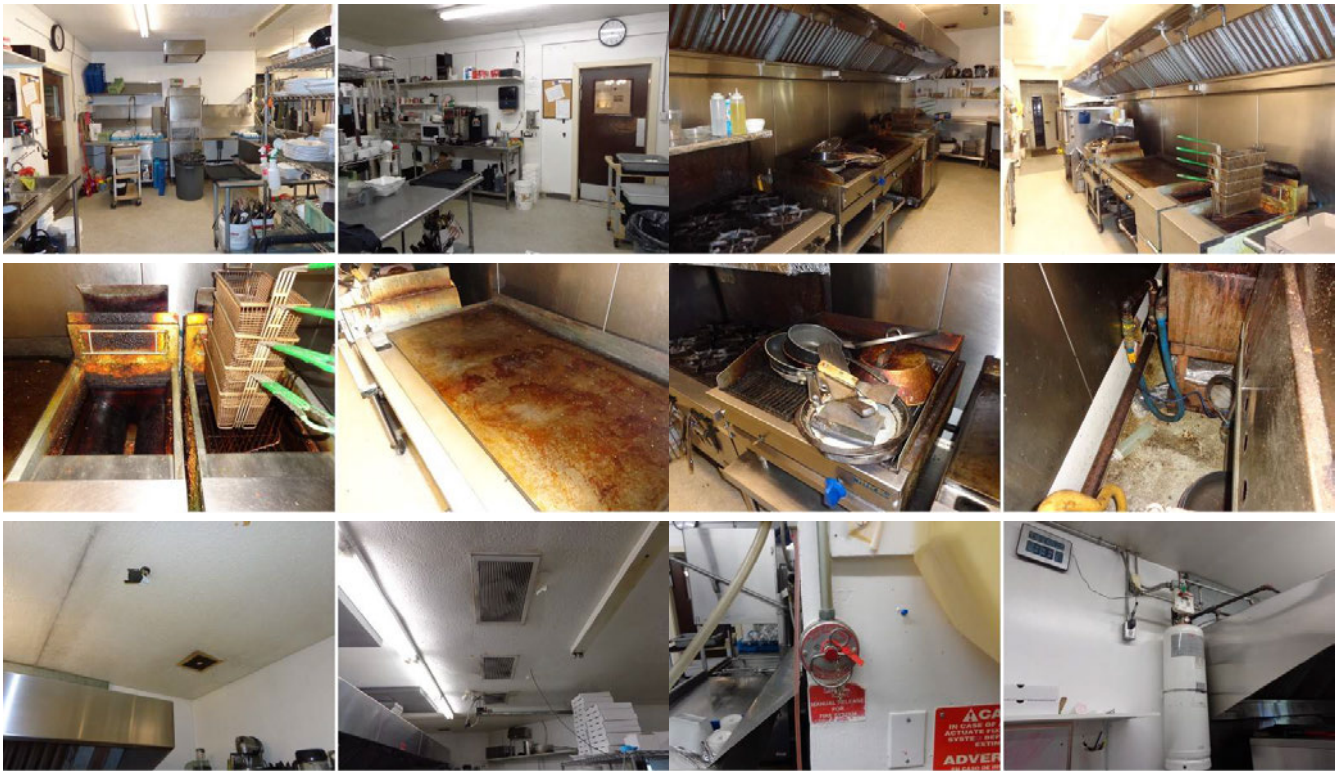
**12.9. Commercial Kitchen:** The building contains a full-service, restaurant-style commercial kitchen equipped with cooking appliances, washing stations, and food storage facilities. At the time of the inspection, the restaurant was not in operation, and both the kitchen and dining areas were shut down.

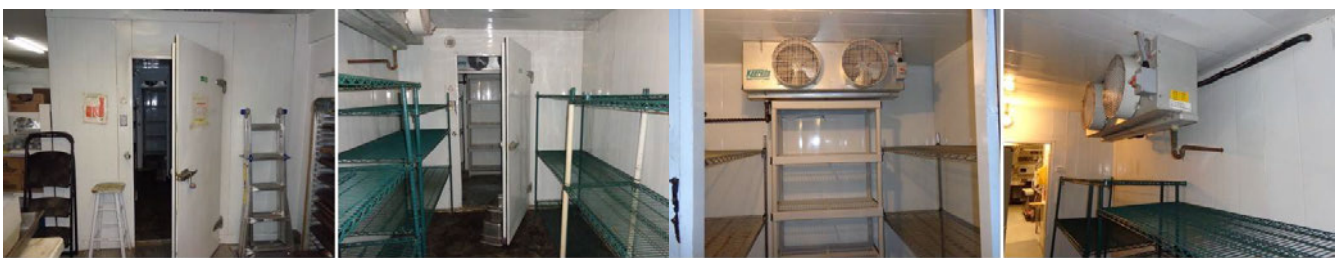
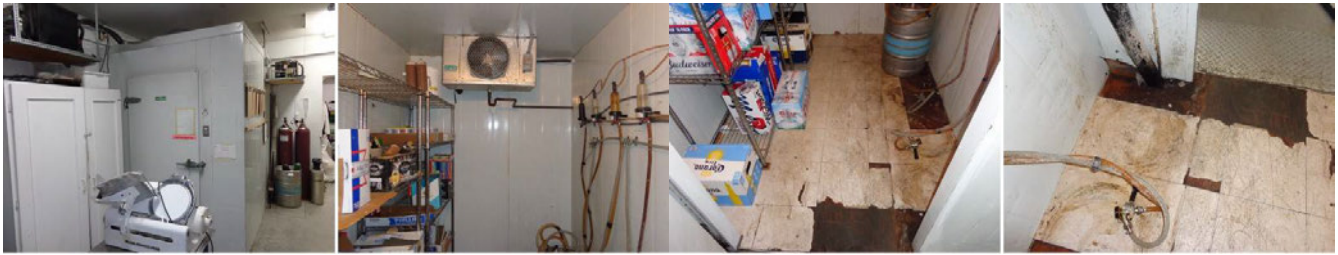
**12.10. Commercial Walk-In Freezers:** The main walk-in freezer is currently non-operational. Both cooling units were shut down at the time of inspection, and their functional status could not be verified.

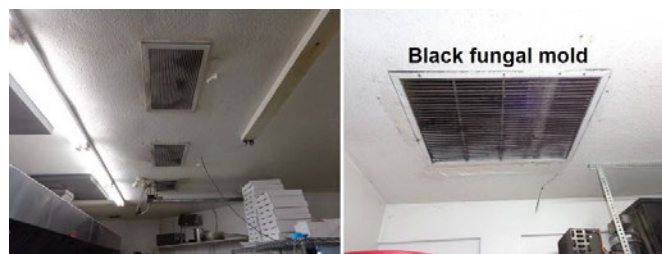
**12.11. Commercial Ventilation Air Exhaust Units:** The kitchen cooking exhaust units were not operational at the time of inspection, and as such, their functional status and condition could not be verified. Other ventilation and exhaust systems that were operational exhibited signs of disrepair, including a lack of visible maintenance and cleaning. Accumulation of grease, dust, or debris may pose operational inefficiencies or potential fire hazards, particularly in commercial kitchen environments.

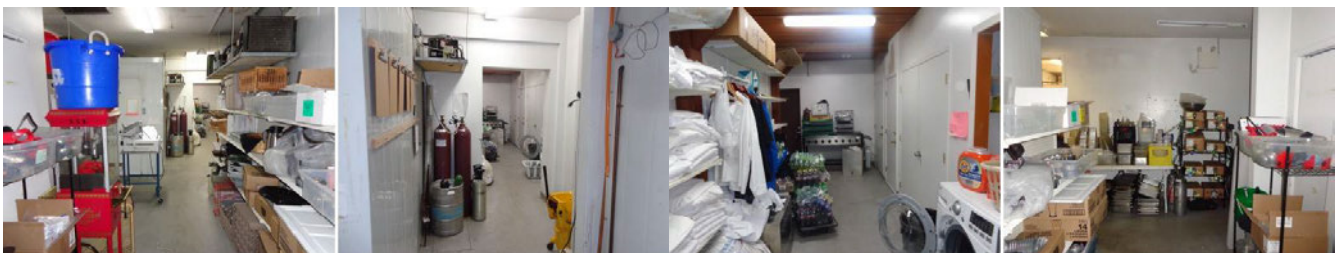
**12.12. Kitchen Common Areas & Storage Rooms:** Conditions appear to be in poor condition.

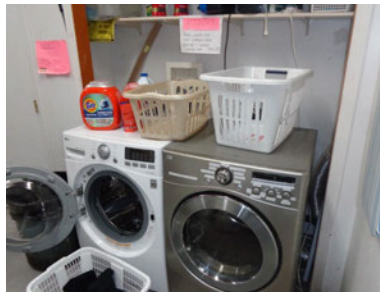
**12.13. Laundry Facilities:** Conditions appear to be in fair condition.

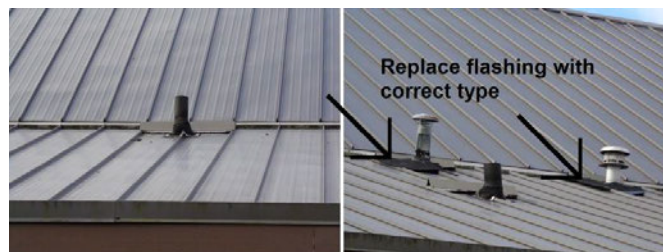
- 13.12. Flashings:** Flashing material appear to be in serviceable condition with the following exception.
- 13.12.1.** At the east side of the roof, two separate metal vents that service a fuel appliance require the rubber flashings to be replaced and install metal flashing.

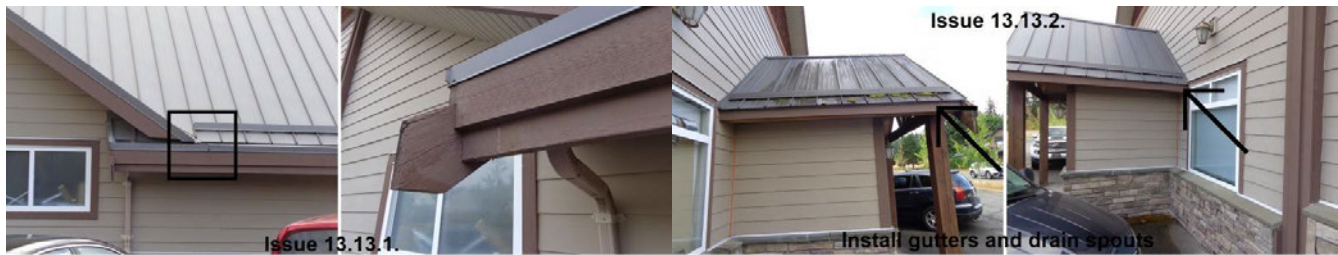
- 13.13. Roof Primary Drains:** The type of water drainage from the roof is gutters and drain spouts. Overall, the gutters and drain spouts appear to be in good serviceable conditions with the following exceptions.
- 13.13.1.** North side of the building, from the right side of the main entry, appears that water from the surface of the roof is not flowing properly into the gutter / drain spout as it appears to be flowing over the gutter.

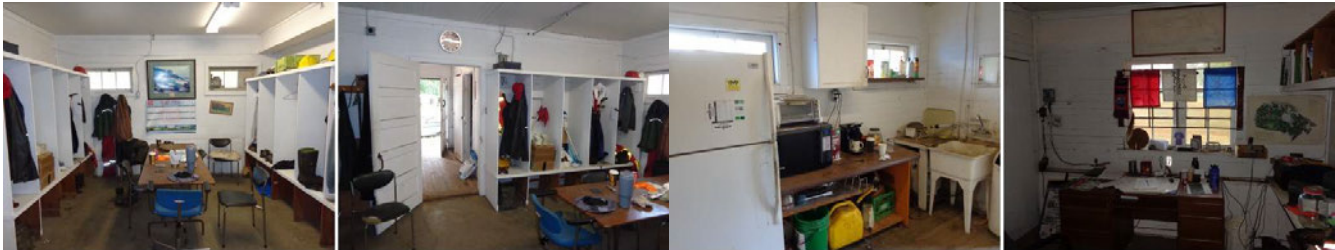
- 33.5. Employee Restroom:** Conditions of the restroom is unknown, door was locked and suspect possible facility unknown issues.
- 33.6. Masonry Chimney:** Located center of the building is an old masonry chimney which is not in use. Appears to be abandoned.
- 33.7. Employee Break Room:** Appears generally serviceable with various cosmetic conditions from aging.
- 33.8. Green Keepers Office:** Appears generally serviceable with various cosmetic conditions from aging.

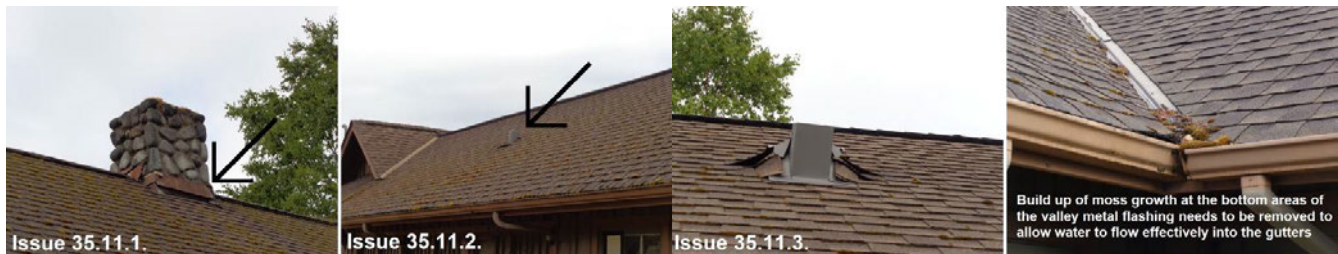
**34.11. Flashings:** The following conditions related to roof flashings were observed:

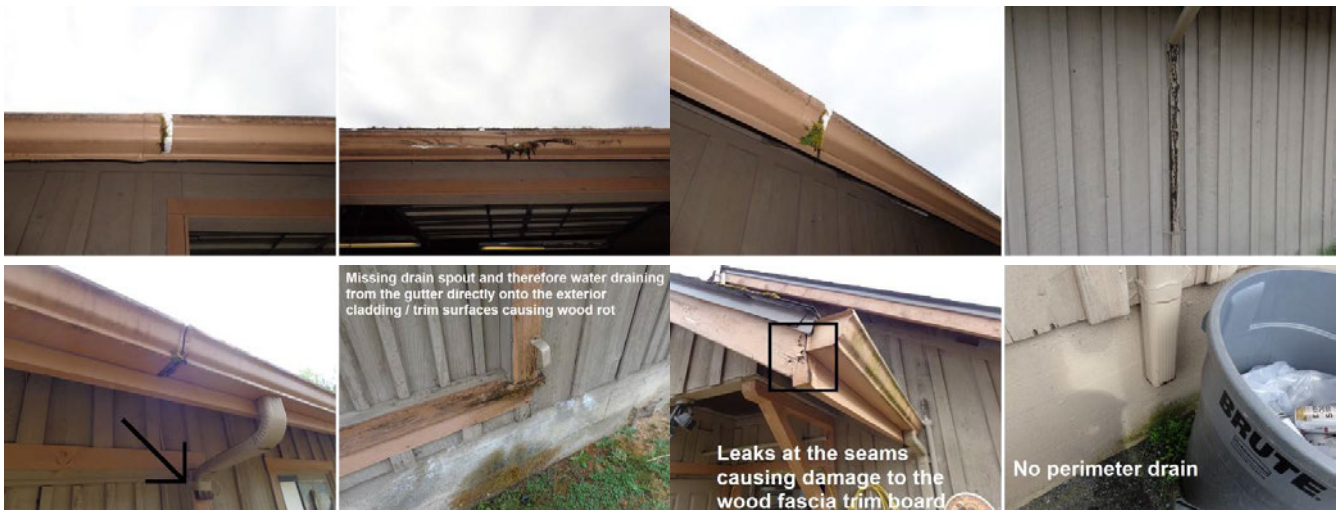
**34.12. Roof Drainage - Gutters & Drain Spouts:** The following conditions and issues to the gutters and drain spouts are viewed at various locations:

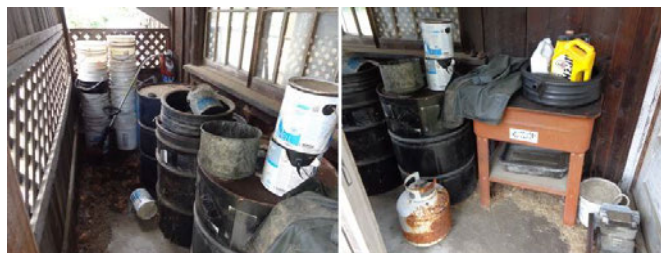
43.2. **Oil Collection Drum/s:** At the **s.15(1)(l)** of the building, there is an enclosed space designated for the storage of used engine oil in multiple barrels. No visible oil spills were observed at the time of inspection. However, it is recommended that the current storage and handling practices be evaluated to ensure compliance with environmental regulations and to prevent any potential environmental contamination or hazards.

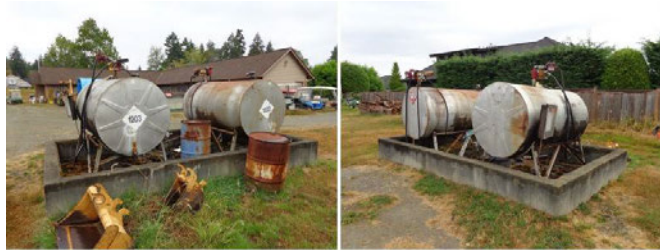
**43.3. Exterior Above Ground Fuel Storage:** The exterior above-ground fuel storage tanks appear to be in serviceable condition and are properly contained within a concrete spill containment enclosure. No visible signs of leakage or structural concerns were observed at the time of inspection. However, the containment enclosure should be cleaned of vegetation and construction debris.

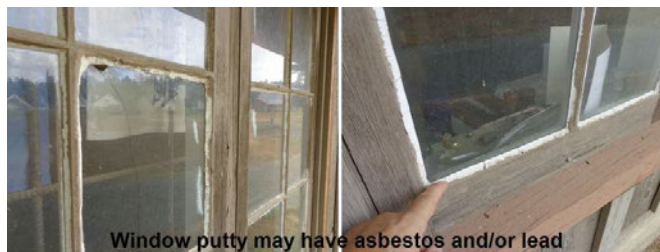
**43.4. Older Building Materials:** Due to the age of the building, there are a mix of older and newer types of building materials. A few older type of construction materials were identified during the inspection that could potentially contain the existing presence of asbestos fibers of which are the following materials that were viewed.

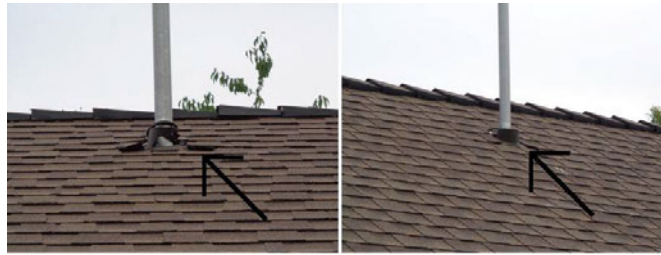
**52.11. Flashings:** The following conditions related to roof flashings were observed:

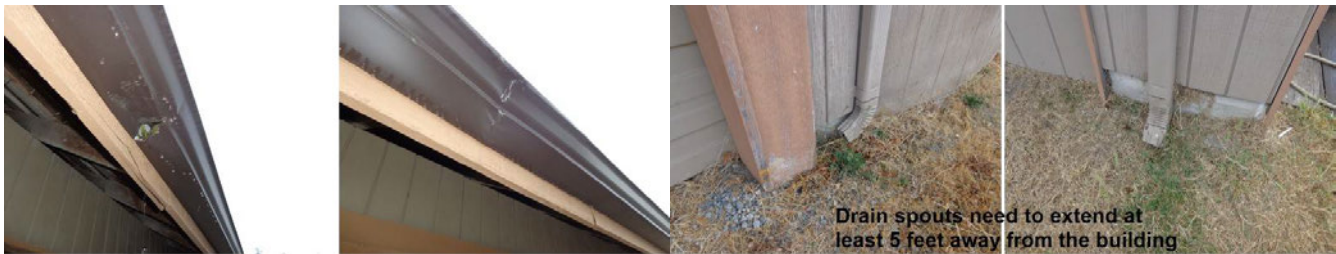
**52.12. Roof Drainage - Gutters & Drain Spouts:** The following conditions and issues to the gutters and drain spouts are viewed at various locations:

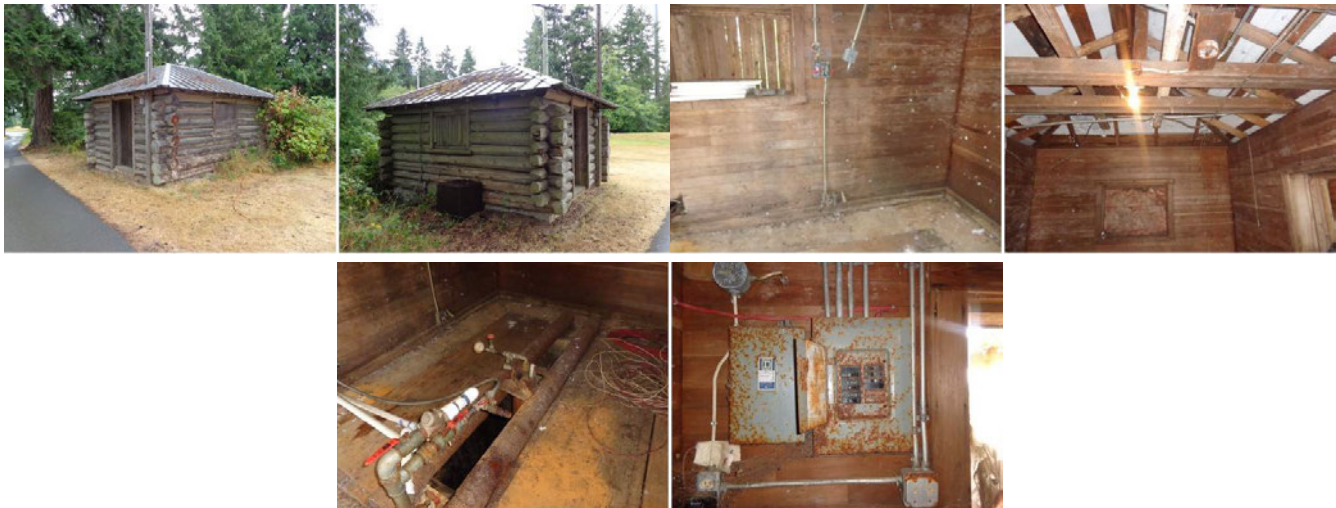
**62.1. Condition Recommendations:** The overall condition of the building, including the water pump equipment and electrical systems, is poor and considered to be at the end of its life expectancy. Due to the deteriorated state of the structure and supporting systems, full replacement of the building and all associated equipment is recommended.

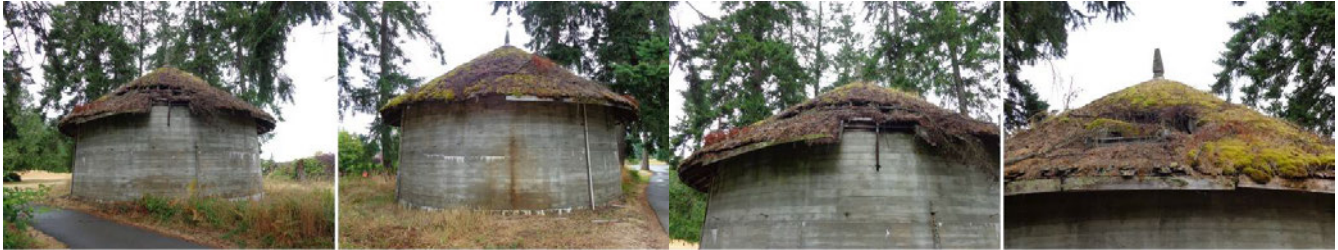
**63.1. Condition Recommendations:** The overall condition of the concrete water tank and roof is poor and considered to be at the end of its life expectancy. Due to the deteriorated state of the structure and supporting systems, recommend to obtain a professional engineer to assess the concrete structure before any repairs are undertaken.

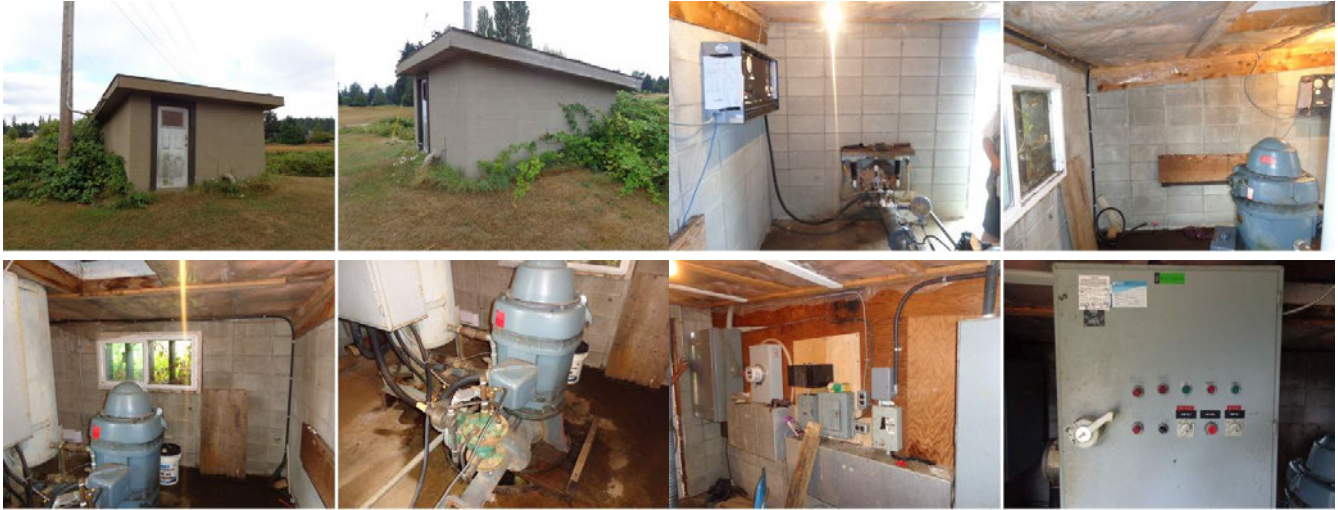
**64.1. Condition Recommendations:** The overall conditions of the building, water pump equipment and electrical appears to be satisfactory serviceable.

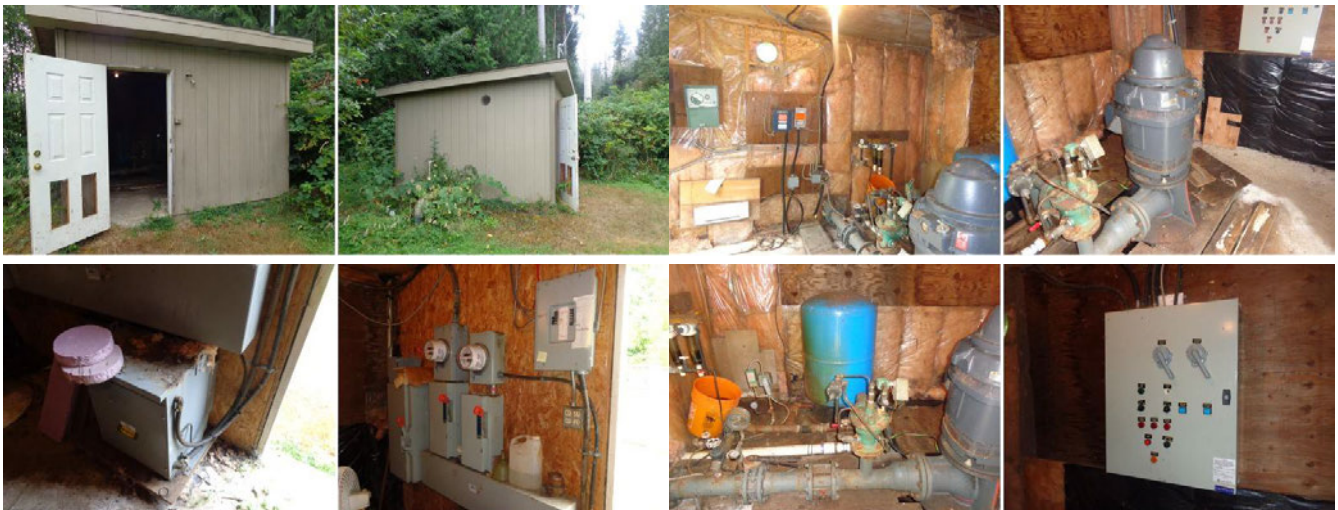
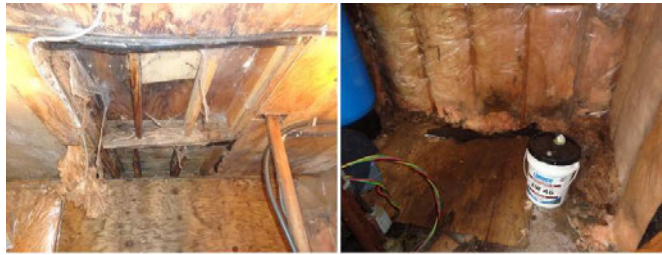
**65.1. Condition Recommendations:** The overall condition of the building structure, including the water pump equipment and electrical systems is very poor, pose electrical hazards and considered to be at the end of its life expectancy. Due to the deteriorated state of the structure and supporting systems, full replacement of the building and all associated equipment is recommended.

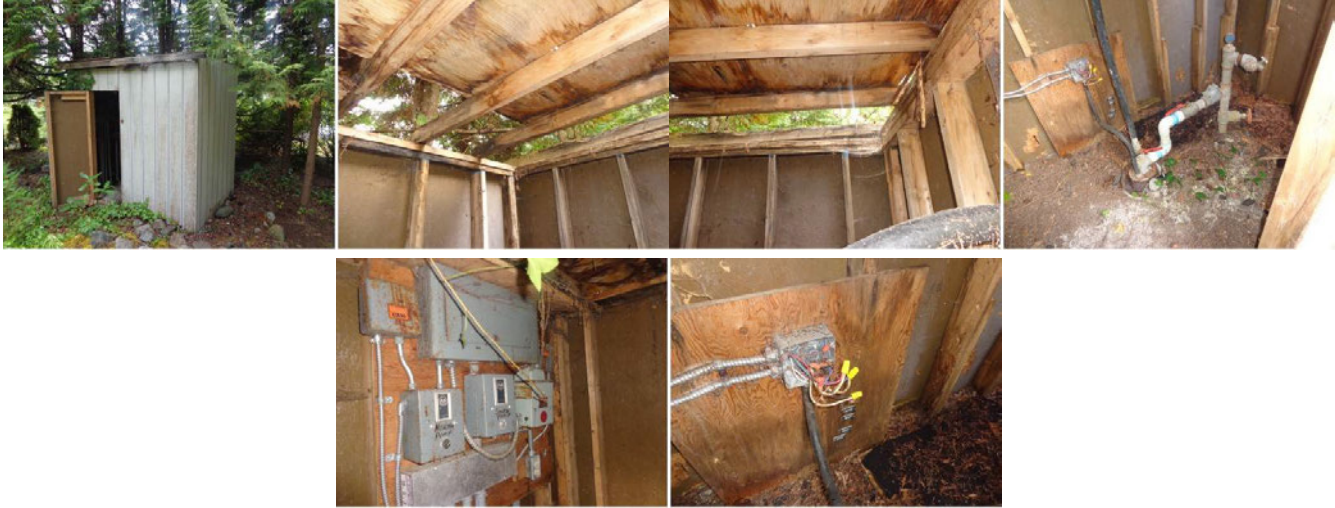
**66.1. Condition Recommendations:** The overall condition of the building structure, including the water pump equipment and electrical systems is very poor, pose electrical hazards and considered to be at the end of its life expectancy. Due to the deteriorated state of the structure and supporting systems, full replacement of the building and all associated equipment is recommended.

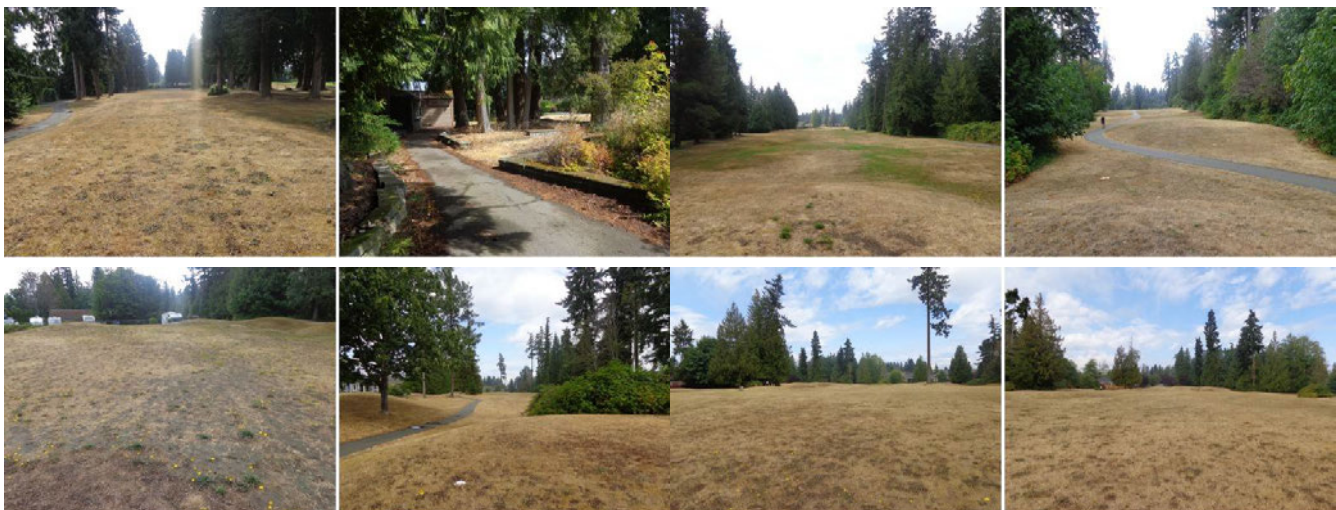
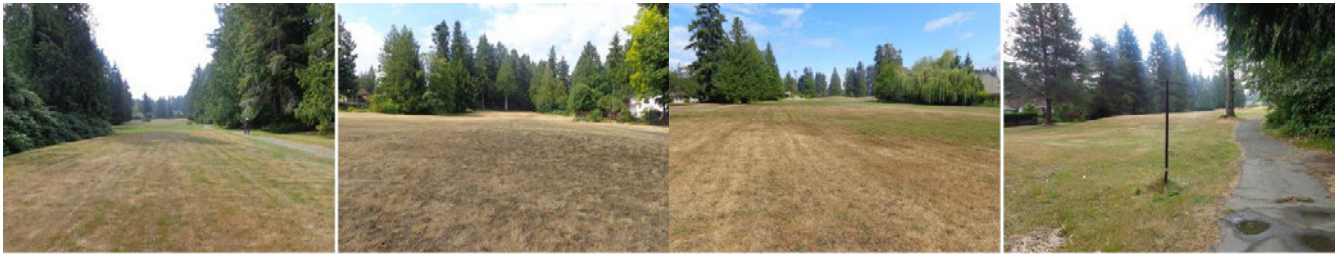
## **69.2. Golf Course Conditions 9-Hole Layout (Abandoned For 5 Years)**

**69.3. Restoring 9-Hole Golf Course:** Restoring a 9-hole golf course fairway system that has been abandoned for five years and can be very costly because essentially rebuilding the playing surfaces from scratch. Costs depend heavily on location, soil conditions, irrigation needs, and whether choosing seeding or sodding. The following costs for restoration of the fairways is based on an estimated 35 acres.
