**Commercial Building Inspection Report**  
**& Property Condition Assessment Survey**  
**Report #: 6861-2025**

**Town of Qualicum Beach**

### **Eaglecrest Golf Course**

**444 Country Club Drive  
Qaulicum Beach, BC.**

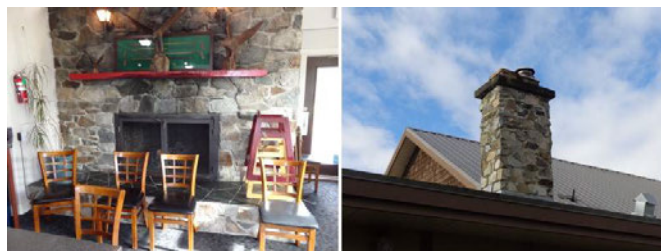
**12.19. Fireplace & Chimney:** Located at the southeast area of the building within the area of the dining room is a solid fuel wood burning fireplace. Due to the age and current conditions, it appears that the fireplace and chimney are not suitable to use (do not meet CSA Standards B365-17 - Installation code for solid-fuel-burning appliances and equipment and/or CAN/CSA-A405-M87 Design and construction of masonry chimneys and fireplaces).

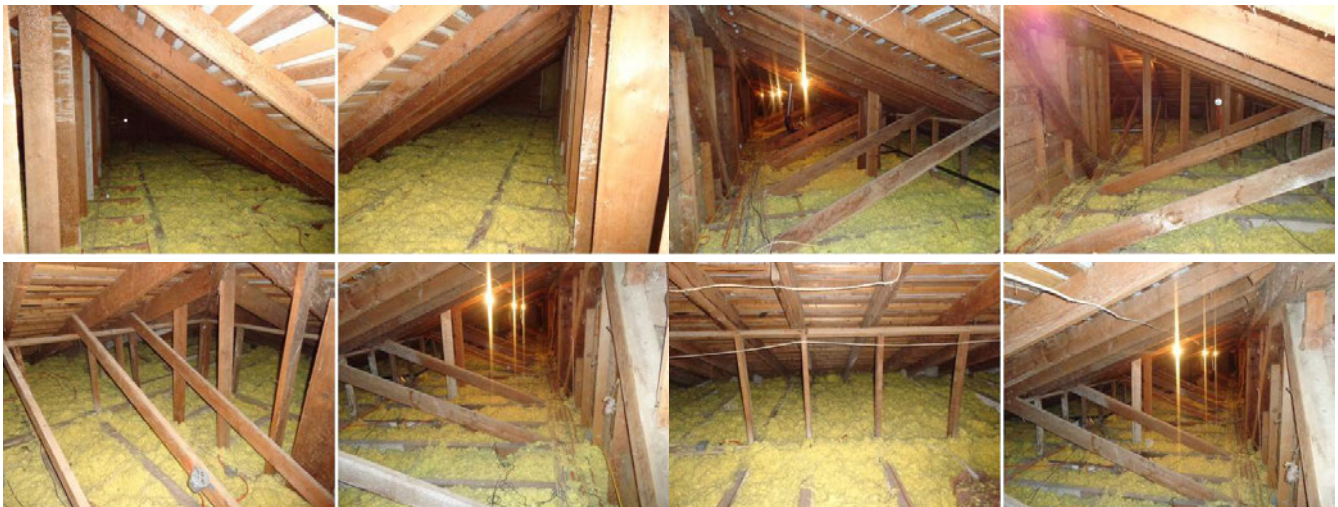
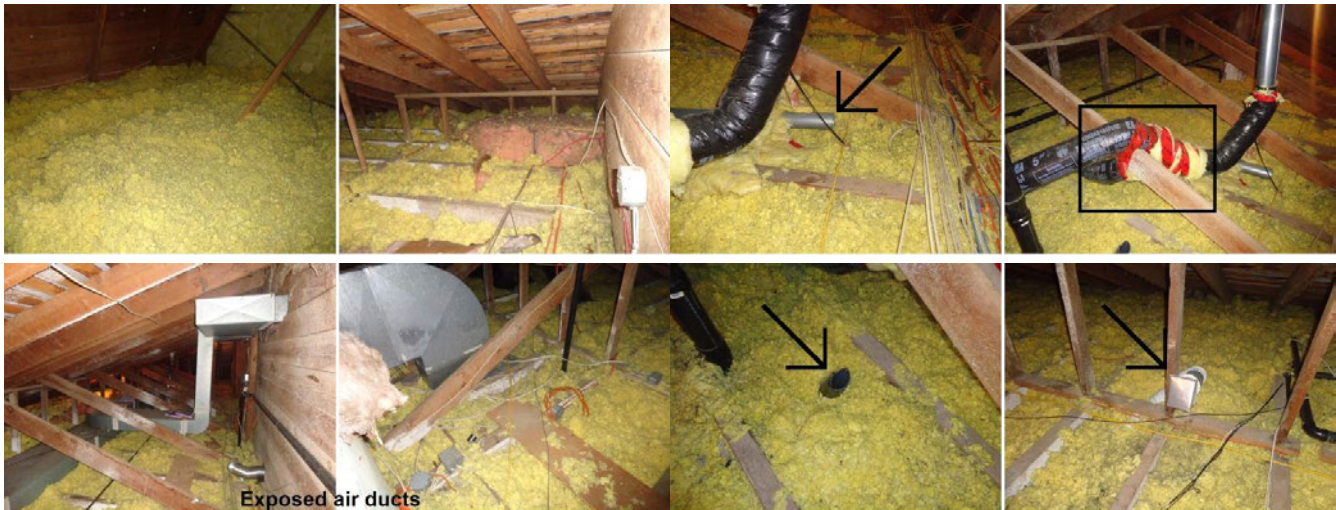
**14.7.2. Improper Vent Termination:** Several mechanical exhaust vents including those from washrooms and other moisture-generating areas were found to terminate directly within the attic space. This is not compliant with building code and can contribute to elevated humidity, condensation, and mold growth within the attic.

**14.8. Conclusion Recommendations:** Recommend to obtain the professional services of a technical and/or contractor specialist to further investigate and undertake the necessary repairs where required.

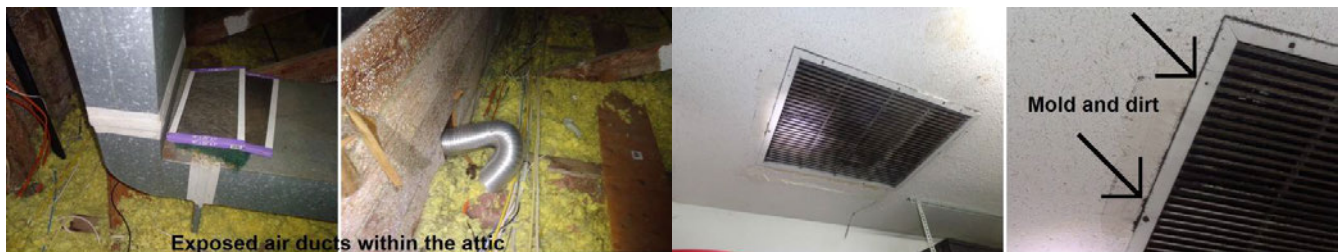
**16.9.1.** The air ducts are very dirty, poor air.

**16.9.4.** Observed metal air ducts within the attic exposed, that is, no insulated and therefore, heat and cooling lose is occurring.

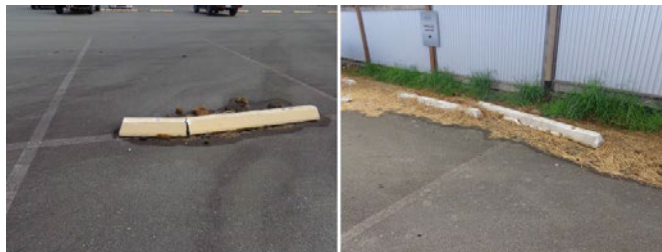
**22.4.2. Wheel Stops:** Throughout the parking areas, several of the wheel stops exhibit damage, overall, appear to be in good serviceable condition.

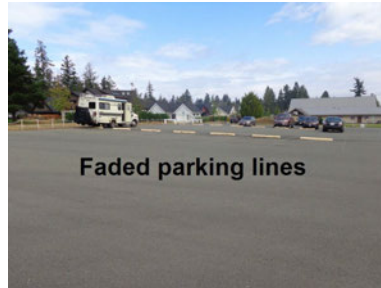
22.7. **Parking Lot Markings:** Irregular and faded parking stall lines require re-painting.

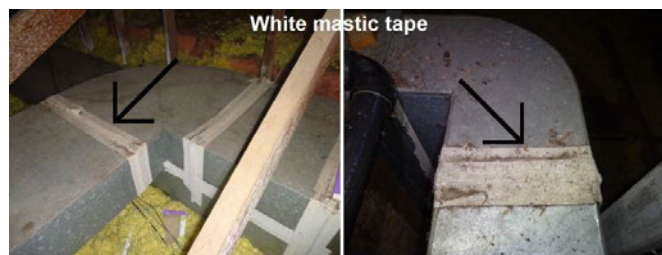
**25.2.5. Indication Item:** White tape like wrapping around metal air ducts.

**25.3. Inquiry & Recommendation:** It is impossible to visually verify why, how, or when these materials came into existence, but they have been known to be associated with containing asbestos fibers. It is advised that all of the materials identified herein and/or known at this time that could or may potentially have asbestos fiber materials be collected of which can be performed by Pacific West Building Inspections and have sent to a qualified Laboratory for testing and a full report forward to you.

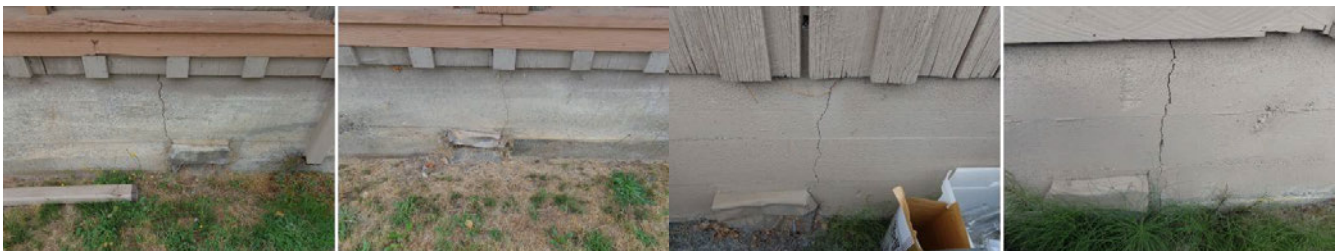
**29.3.4. The Following Conditions Where Observed Of The Foundation:** Small to moderate cracks are observed within the foundation at various locations.

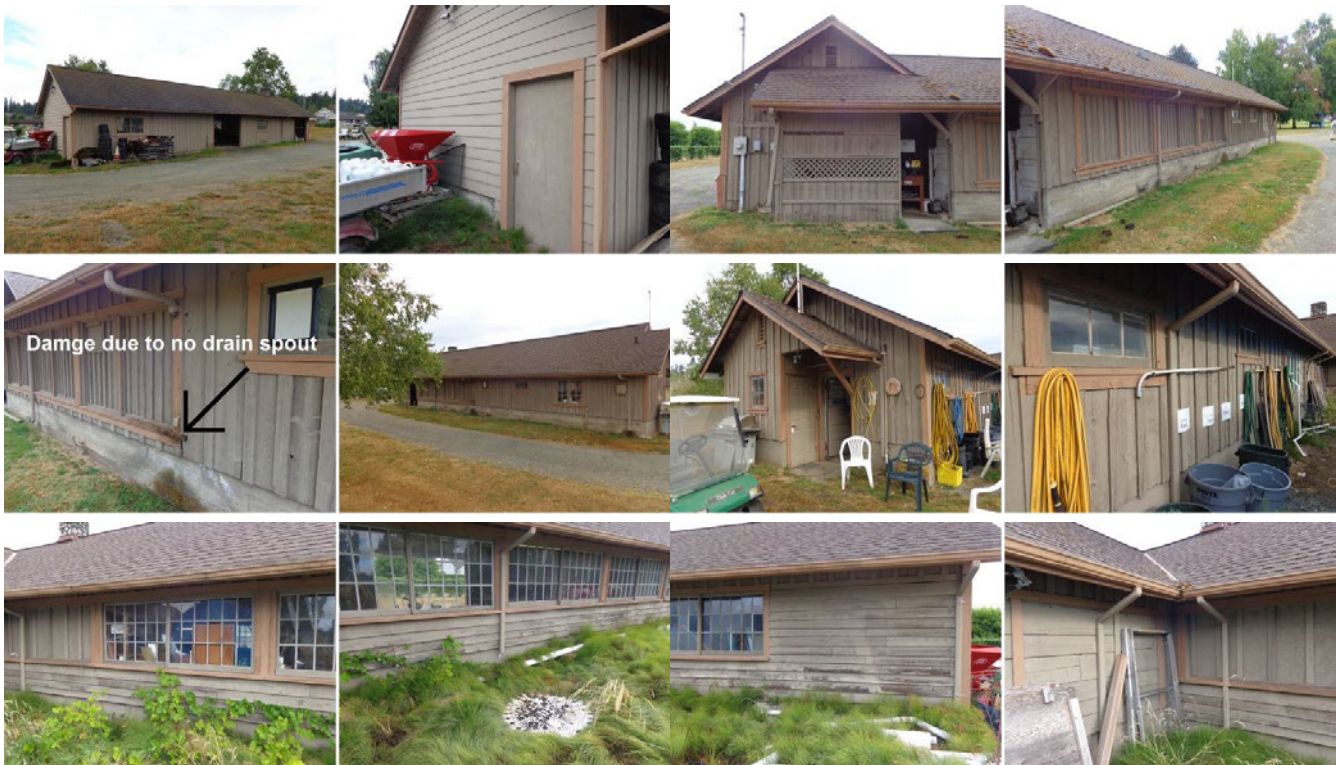
- 30.6. **Building Framing:** N/A.
- 30.7. **Cladding:** Conditions of the cladding are the following observed.
  - 30.7.1. **Hardi-board / Plank:** Appears to be in satisfactory serviceable condition.
  - 30.7.2. **Wood:** Siding material exhibits minor deterioration and aging at various locations.
- 30.8. **Trim - Flashing - Sealants:** Trim, flashings and sealants exhibit minor to moderate deterioration, some wood rot due to water and moisture, light damage, missing flashing and sealants at various locations.

**30.10. Conclusion Recommendations:** Recommend to obtain the professional services of a technical and/or contractor specialist to further investigate and undertake the necessary repairs where required.

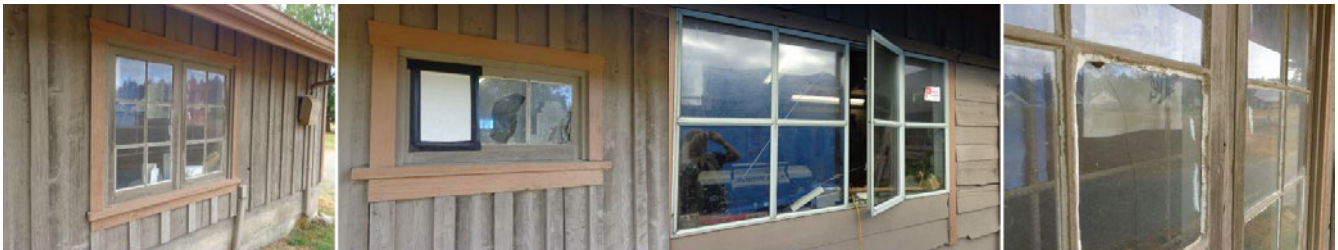
**32.4.1.** Older wood framed windows exhibit deterioration to the framing and trim, several have broken glass.

**32.4.2.** Aluminum windows exhibit broken glass.

**32.5. Doors:** Doors and framing exhibit material deterioration, light damage, aging.

**32.7. Recommendations:** Recommend to obtain a professional contractor or specialist to update the windows and exterior doors due to present conditions.

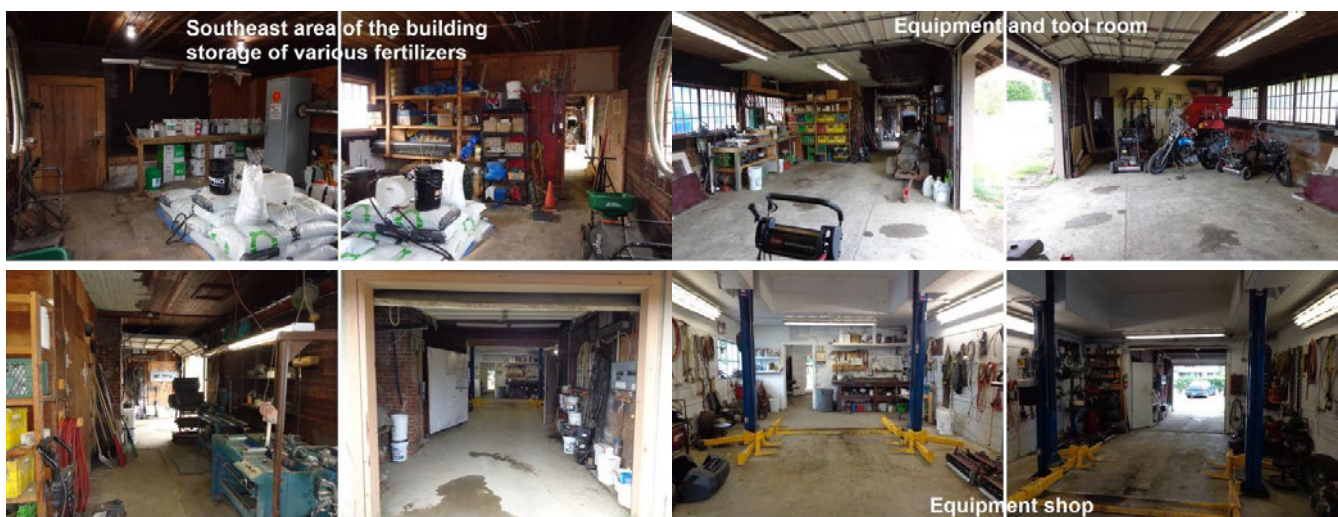
**33.4. Ceiling & Wall Conditions:** Due to the age and purpose of the building, the interior walls and ceilings exhibit various material deterioration, wear and cosmetics as expected.

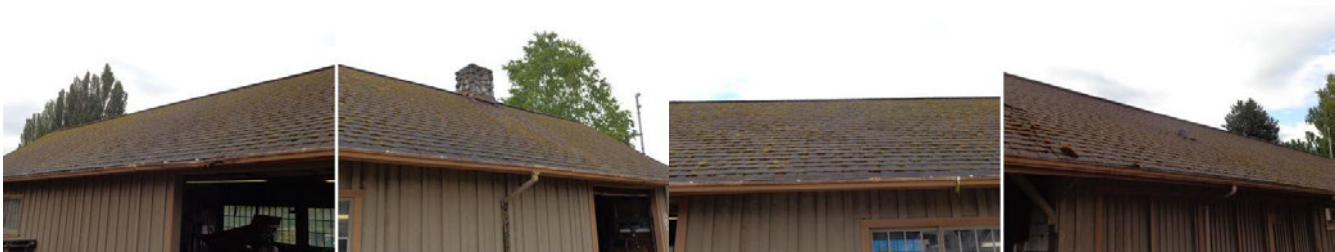
- 34.10. Main Building Roof:** Roof covering material appears to be in satisfactory serviceable conditions. However, light to heavy moss growth is present on the surfaces and needs to be removed.

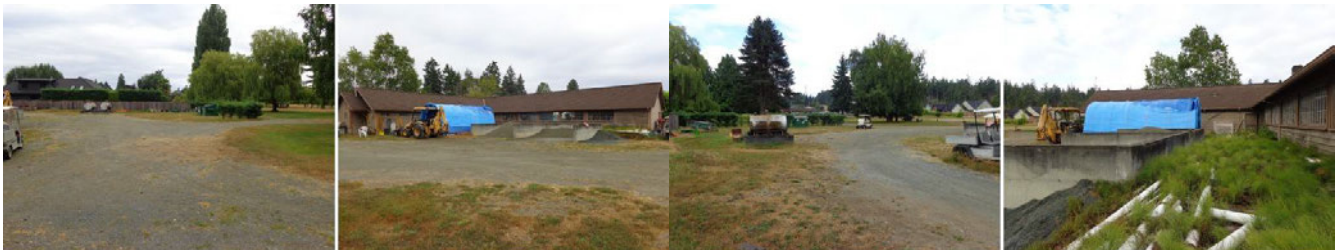
- 41.1. **Landscaping:** The surrounding landscape is in satisfactory condition (work yard).
- 41.2. **Topography Grade & Slope:** The grade of the property is satisfactory sloping away from the foundation with the exception at the southeast side of the building (overgrown / pipes, etc). Overall, site drainage is satisfactory.

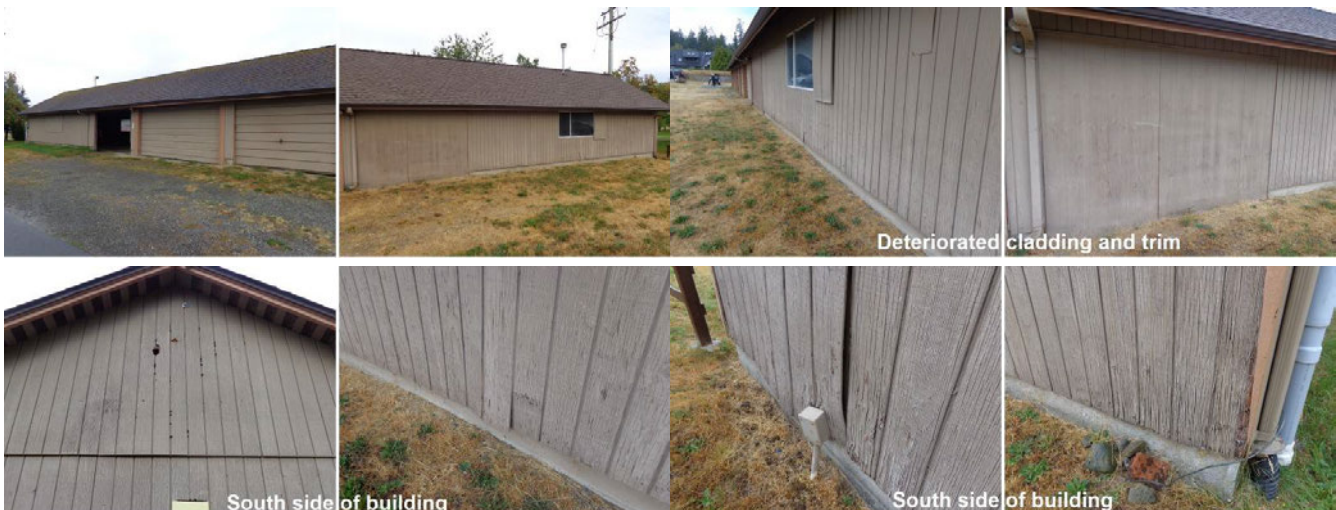
**48.10. Conclusion Recommendation Requirements:** Due to the present conditional issues viewed, obtain the professional services of a professional contractor to undertake minor maintenance repairs and/or material replacement as and where needed to protect building materials.

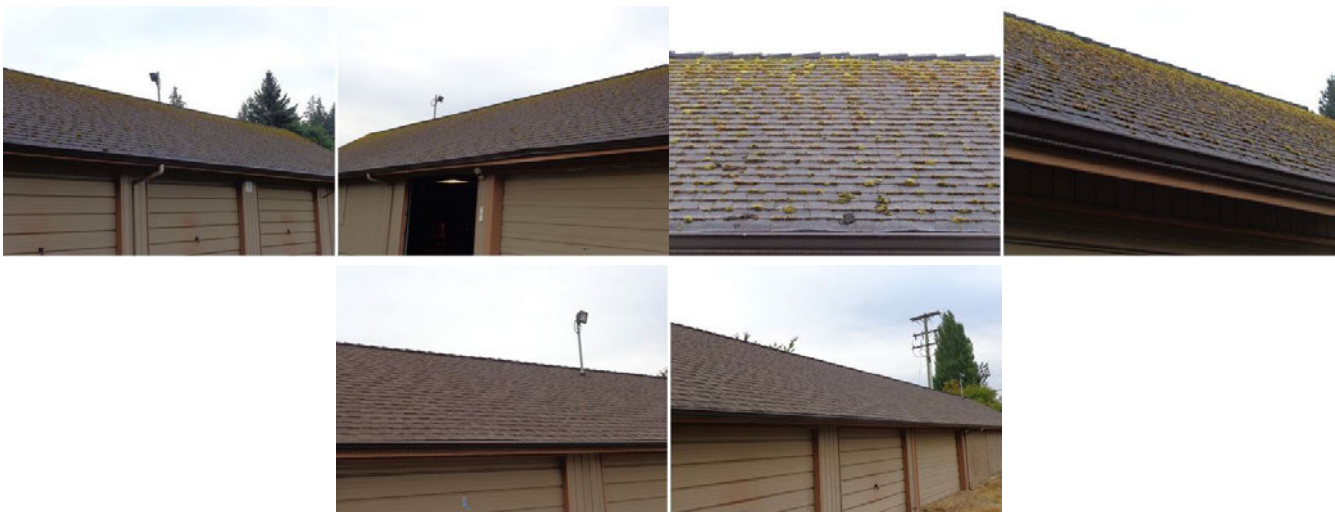
**52.10. Main Building Roof:** Roof covering material appears to be in satisfactory serviceable conditions. However, light to heavy moss growth is present on the surfaces and needs to be removed.

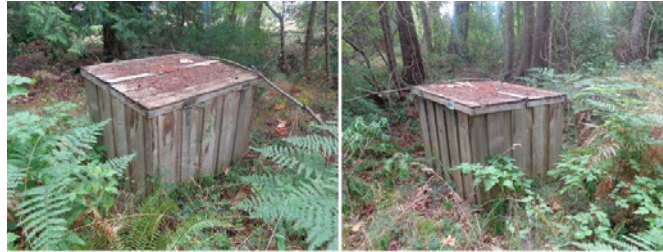
This structure is located at the **s.15(1)(l)** of the property. The structure of the building is constructed of wood framing. Access was not achievable and therefore, further investigation is required to assess the electric water well pump system along with associated electrical services.

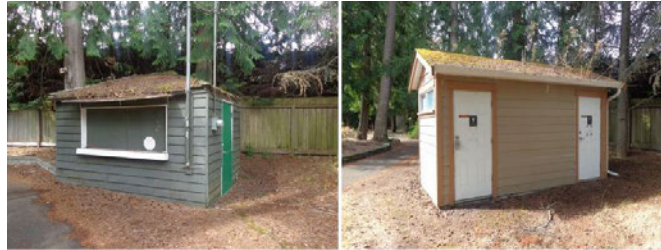
Located in the southern section of the closed-off area of the golf course, the concession stand and restroom building sit between the original 4th and 11th holes. When the current owners closed 9 of the 18 holes in 2021, both buildings were also shut down and boarded up. They are currently locked, with no available keys, and as a result, the interior conditions—including electrical and plumbing systems—are unknown. The exteriors of both buildings show signs of wear and require maintenance and general upkeep.

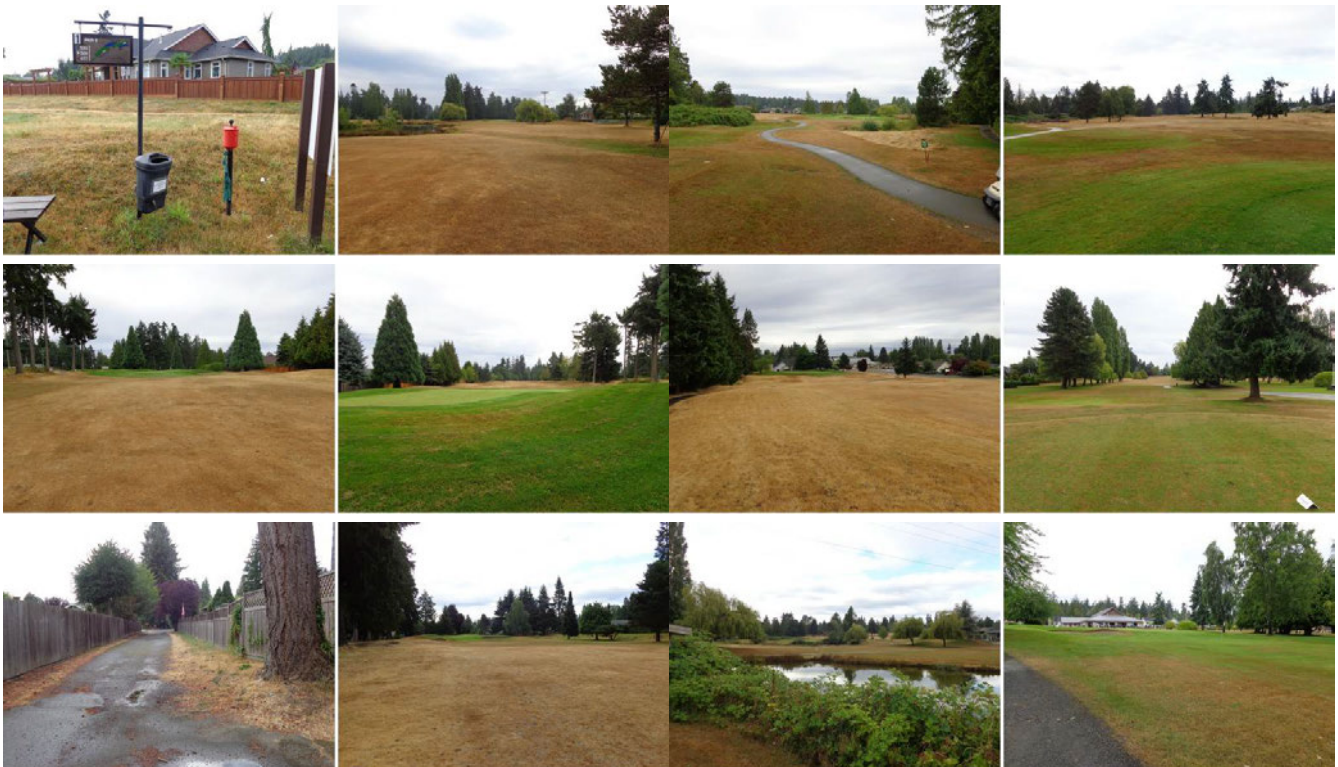
**69.1.4. Cart Paths:** The cart paths are in fair condition, with several areas exhibiting cracking, erosion, and tree root and weed overgrowth. Some paths have deteriorated to the point of being uneven or hazardous for cart travel. Sections composed of gravel or dirt may require re-grading or resurfacing. Restoration of the cart paths would improve overall course access and reduce wear on turf from off-path cart travel.
